NACA RM E53G02

PRELIMINARY INVESTIGATION OF SEVERAL ROOT DESIGNS FOR
CERMET TURBINE BLADES IN TURBOJET ENGINE

II - ROOT DESIGN ALTERATIONS

By A. J. Meyer, Jr., G. C. Deutsch, and W. C. Morgan

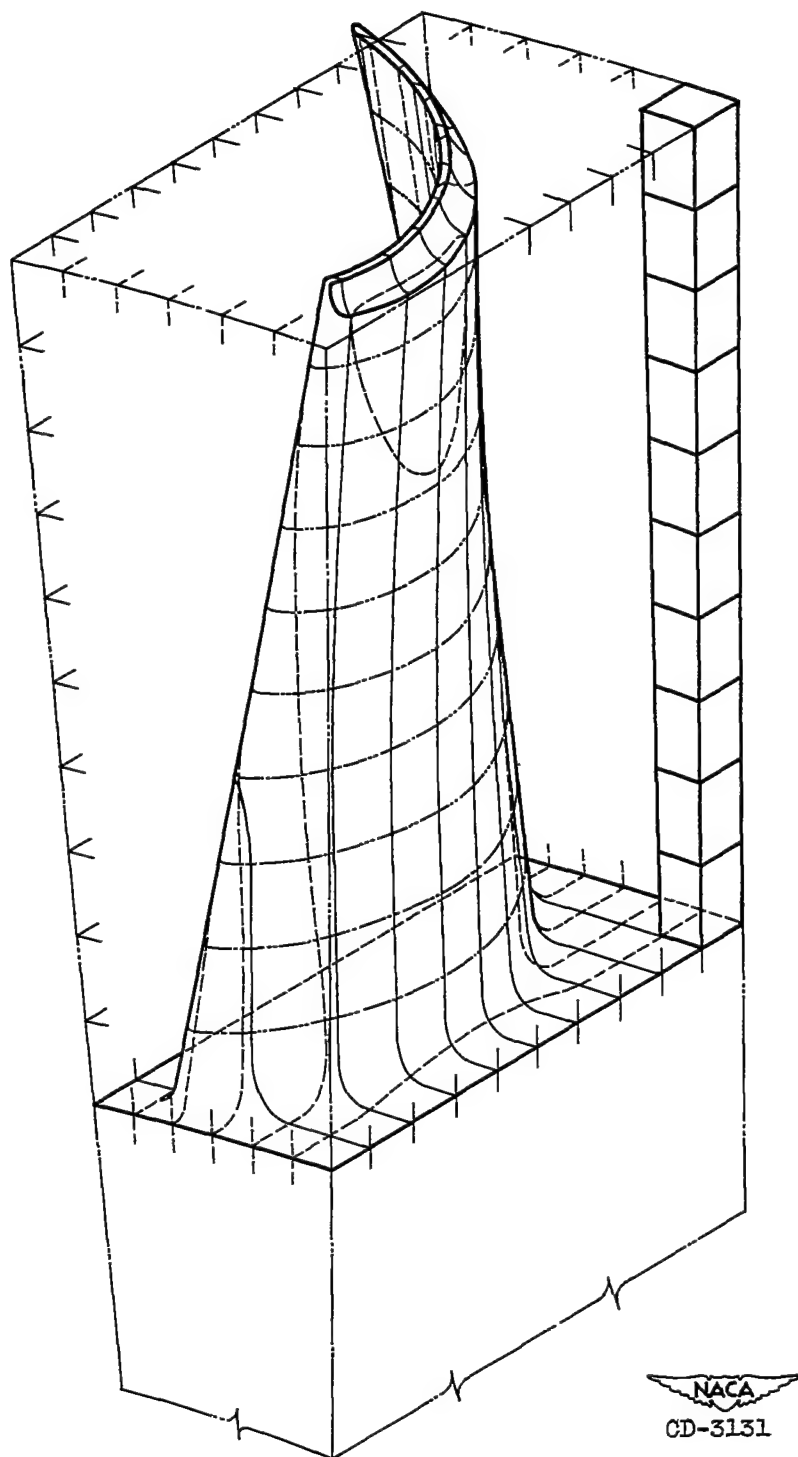
If the profile of the airfoil at its base is superimposed on the photograph of a fractured root surface (fig. 8), it becomes apparent that the failure invariably starts at the location of the largest concentration of mass of the airfoil. The presence of bending stresses in the root neck is evident because the failure generally starts at the

Figure 8. - Airfoil profile superimposed on failure surface.
